Technical Memorandum

To: Ed Carter
From: David Morris, P.E.
Date: September 16, 2019
Re: Route 7, Clarke County, Roadway Safety Assessment

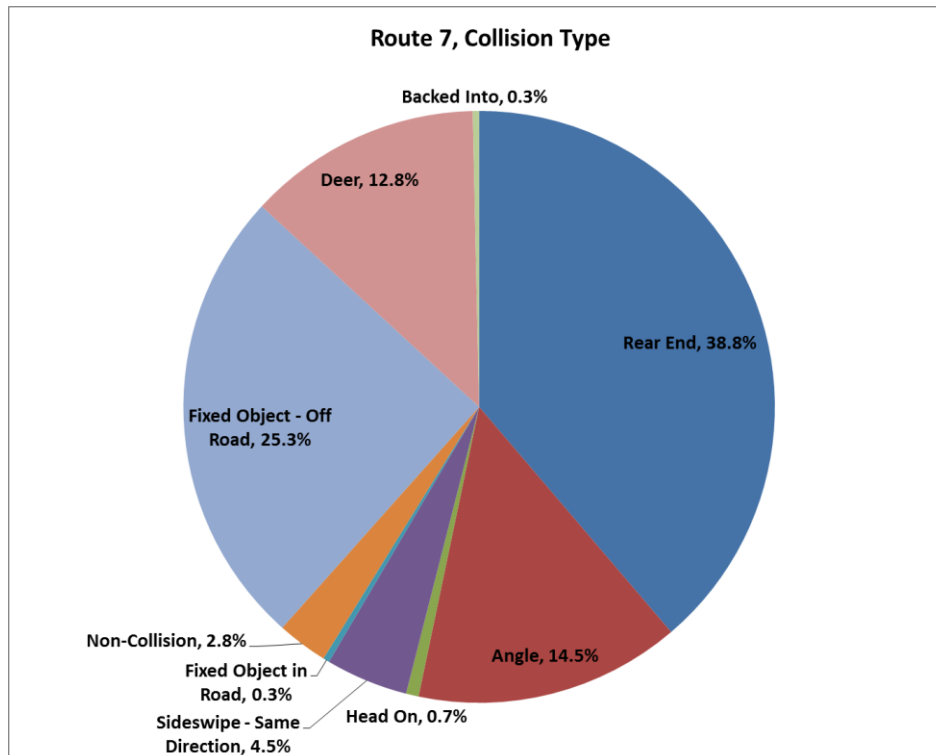
Chart 1, Route 7 Crash Types

Within the review limits, 289 crashes occurred during the time period of January 1, 2016 and December 31, 2018. Of these crashes, there was 1 fatal crash, 98 injury crashes and 190 property damage only crashes. The following chart shows the breakdown by type of crashes. The four most common types are Rear Ends (39%), Fixed Object Off-Road (25%), Angle (15%), and Deer (13%).

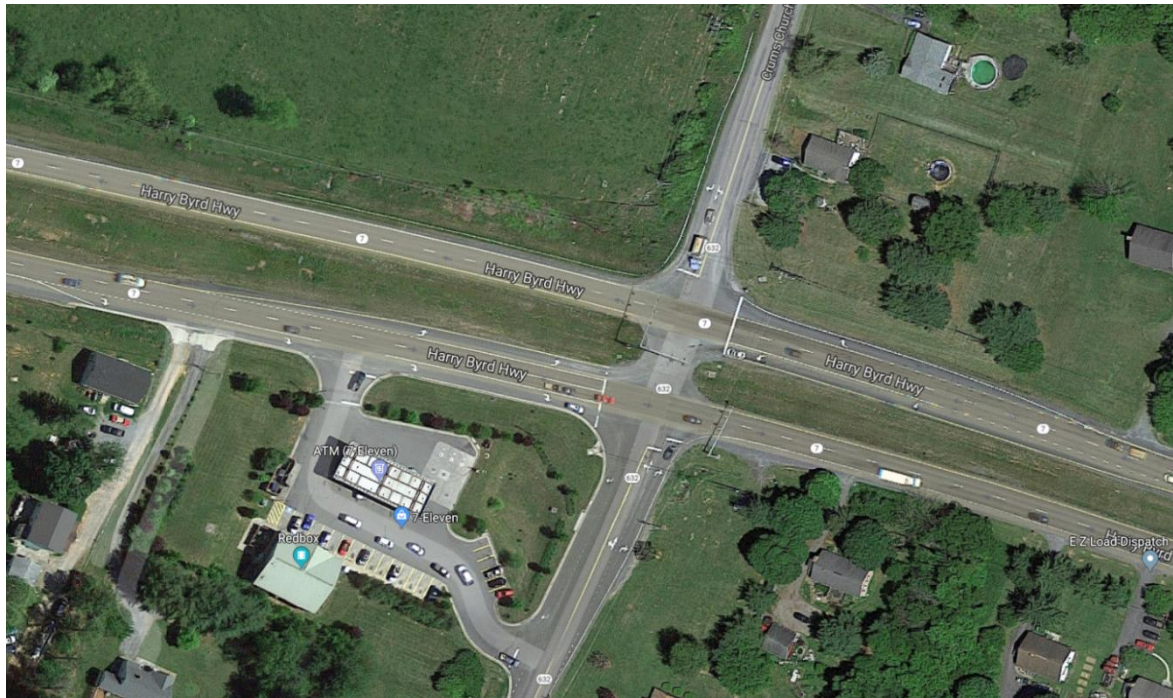
Route 7 and Route 632 is a four-leg intersection with all approaches operating under SIGNAL control. See the following figure for aerial view of existing conditions.

The review found 11 crashes resulting in 9 injuries and 1 fatality. The most frequent crash type (6 of 11) was rear end crashes where there were 4 in the eastbound direction and 2 in the westbound direction. There was 1 red-light running crash in the westbound direction and 1 in the southbound direction. Also, there was one crash in the crossover and one at the 7-Eleven entrance on Route 632.

1. Install high-visibility back plates to the signal heads on all approaches.
2. Install WATCH FOR STOPPED VEHICLES signs, both on the right and left sides of eastbound Route 7 at approximately 1,000 feet west of the intersection.
3. Review existing video detection zones to determine if there is an opportunity to increase the advanced detection.

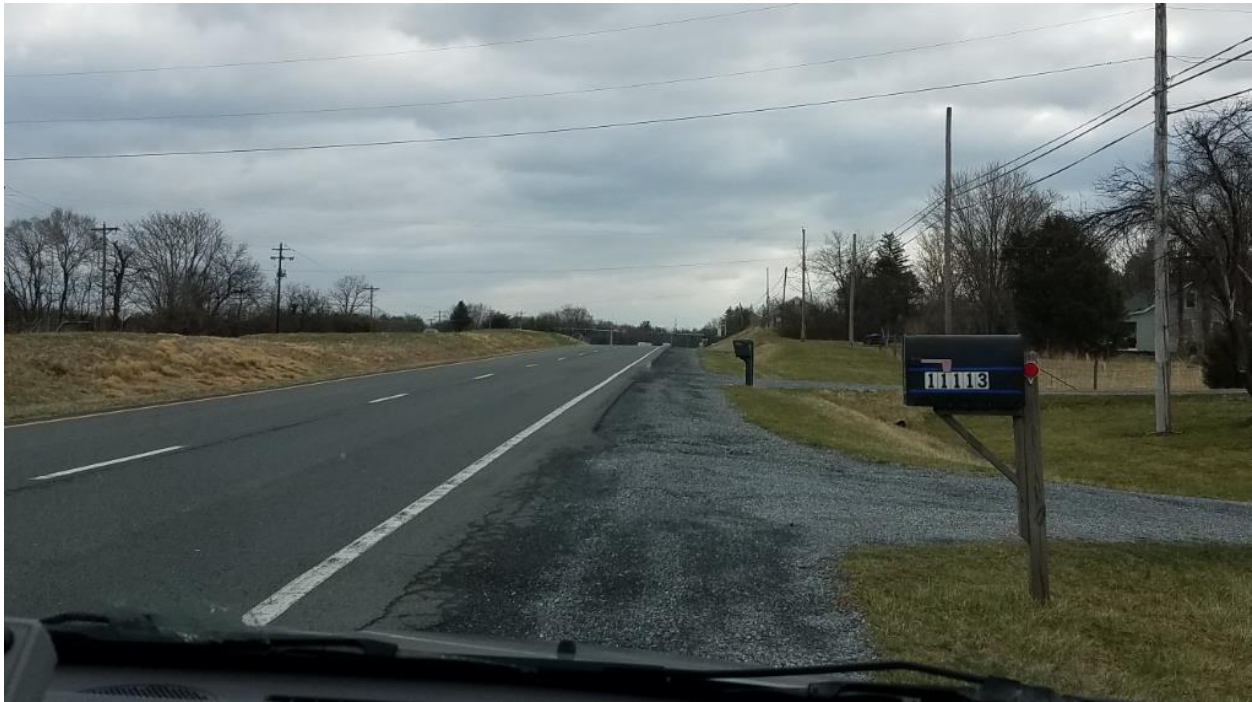
There is a slight crest vertical curve in the eastbound lanes west of the intersection that cars can disappear behind.

Slight Crest Vertical Curve Eastbound

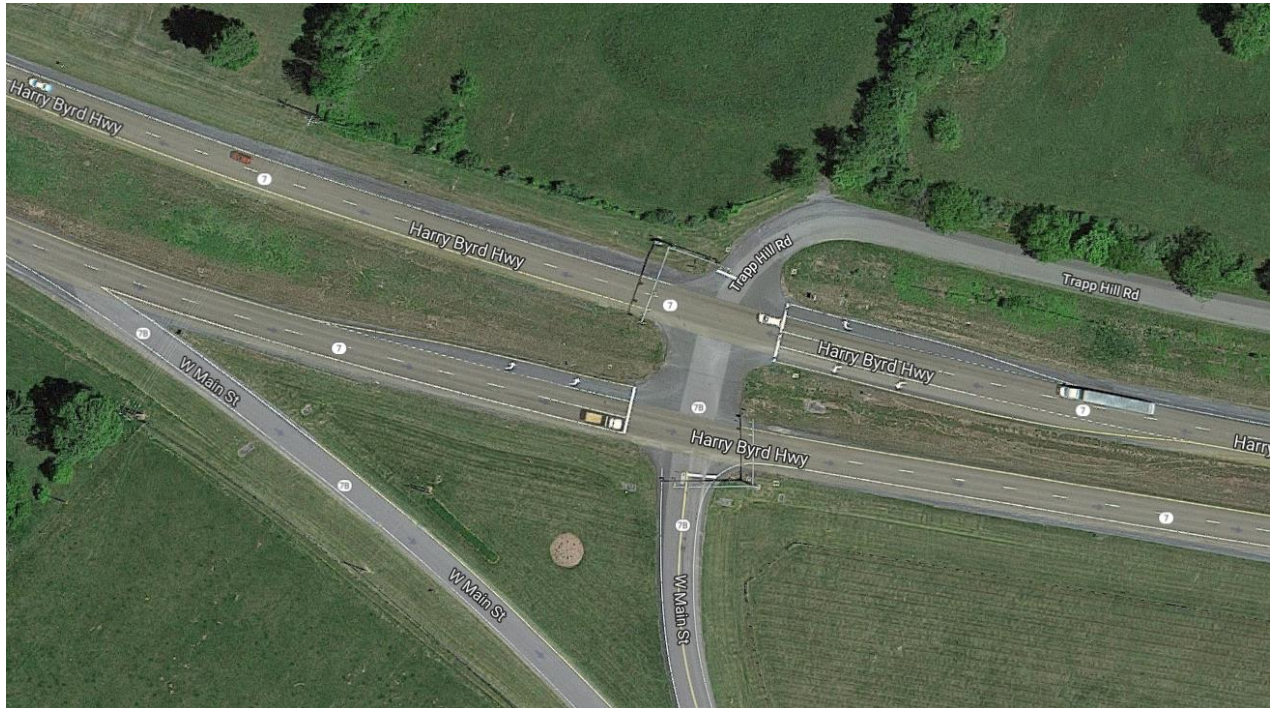
Route 7 and Route 7 BUS (W. Main St.) is a four-leg intersection with all approaches operating under SIGNAL control. See the following figure for aerial view of existing conditions.

The review found 12 crashes resulting in 8 injuries, 0 fatalities. The most frequent crash type (5 of 12) was rear ends in the eastbound direction. There were 2 additional crashes in the eastbound direction that were a result of a driver running a red light.

1. Install high-visibility back plates to the signal heads on all approaches.
2. Install WATCH FOR STOPPED VEHICLES signs, both on the right and left sides of eastbound Route 7 at approximately 1,000 feet west of the intersection
3. Review existing video detection zones to determine if there is an opportunity to increase the advanced detection.

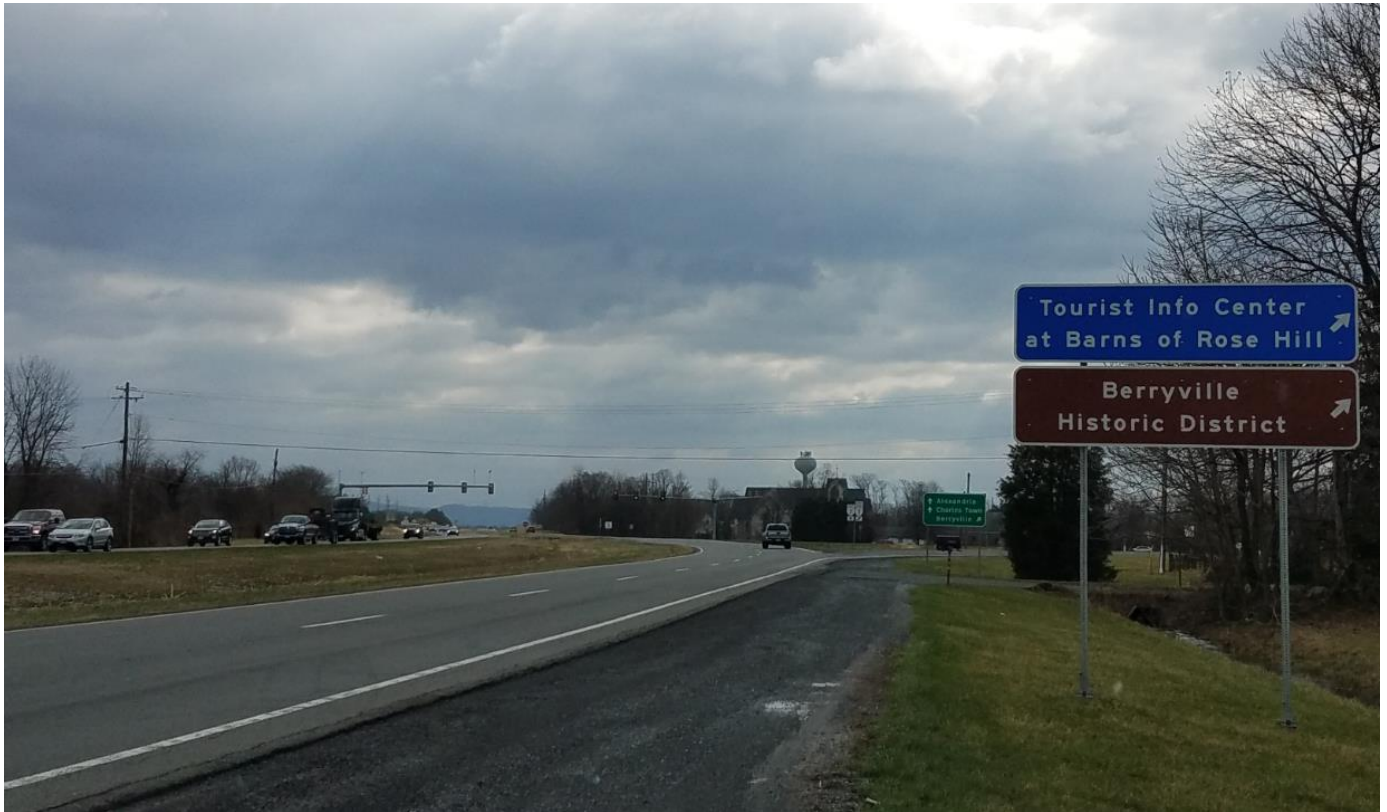
There are existing Signal Ahead warning signs with flashers on both the eastbound and westbound approaches.

Route 7 eastbound Signal Head Visibility

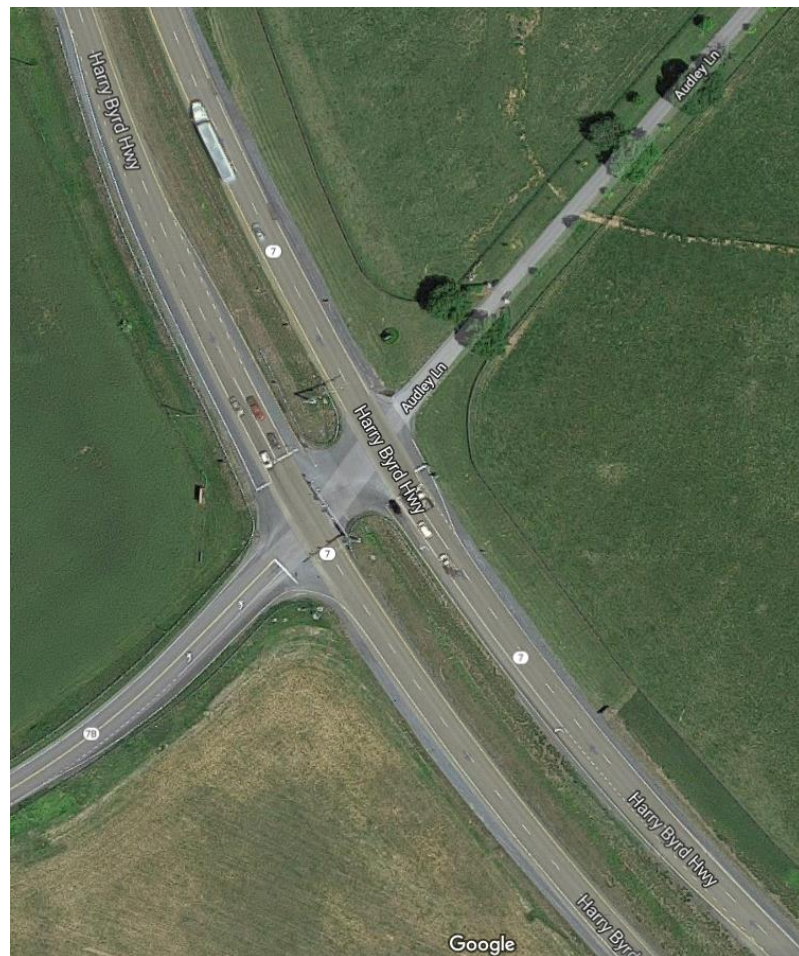
Route 7 and Route & 7 BUS (E. Main St) is a four-leg intersection (one private driveway) with all approaches operating under SIGNAL control. See the following for an aerial view of existing conditions.

The review found 11 crashes resulting in 2 injuries, and 0 fatalities. The most frequent crash type (8 of 11) was rear end crashes of which 6 occurred in the westbound direction with two of those in the left turn lane. One was on a snowy road, two were driver distraction.

1. Install high-visibility back plates to the signal heads on all approaches.
2. Relocate signs on the westbound right shoulder to increase signal head visibility.
3. Install WATCH FOR STOPPED VEHICLES signs, both on the right and left sides of westbound Route 7 approximately 1,000 feet east of the intersection
4. Review existing video detection zones to determine if there is an opportunity to increase the advanced detection.

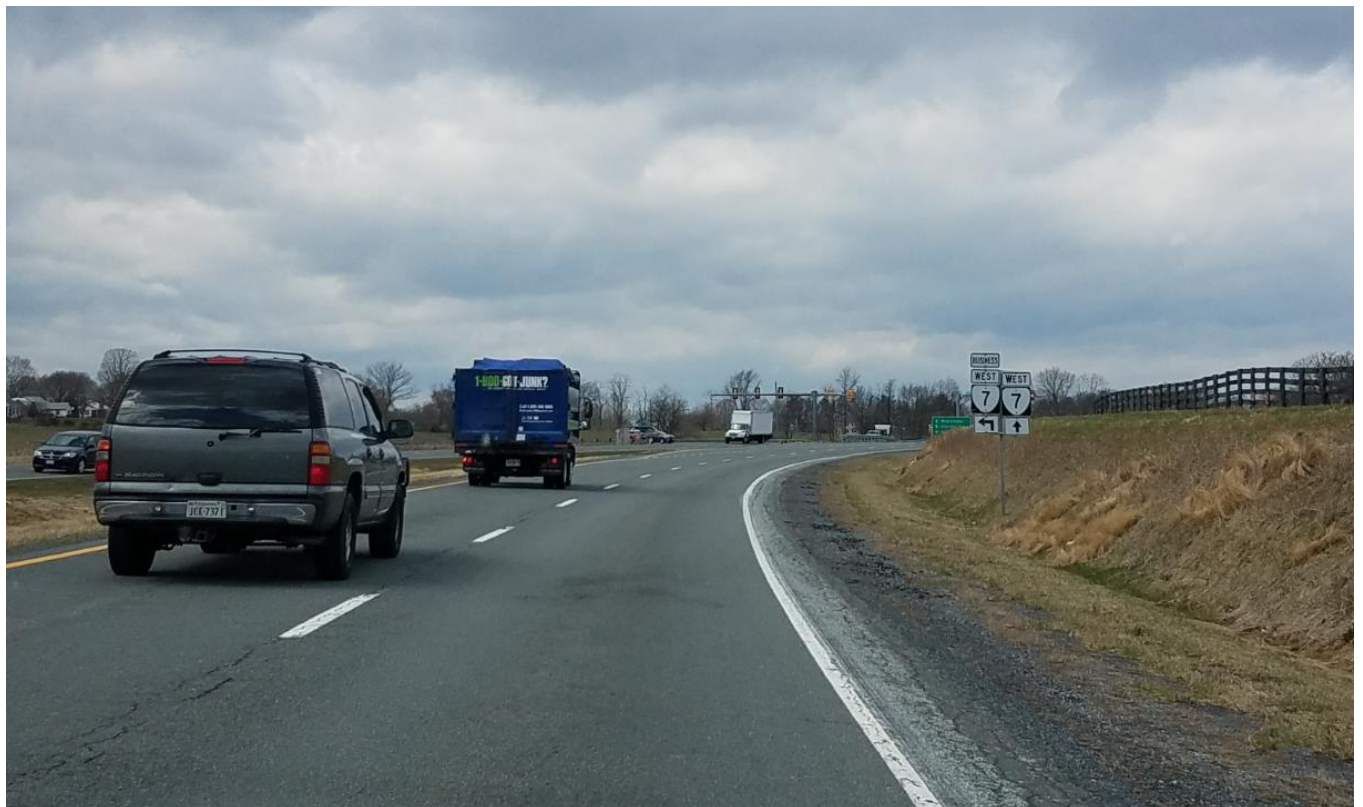
Route 7 westbound, signs blocking signal heads

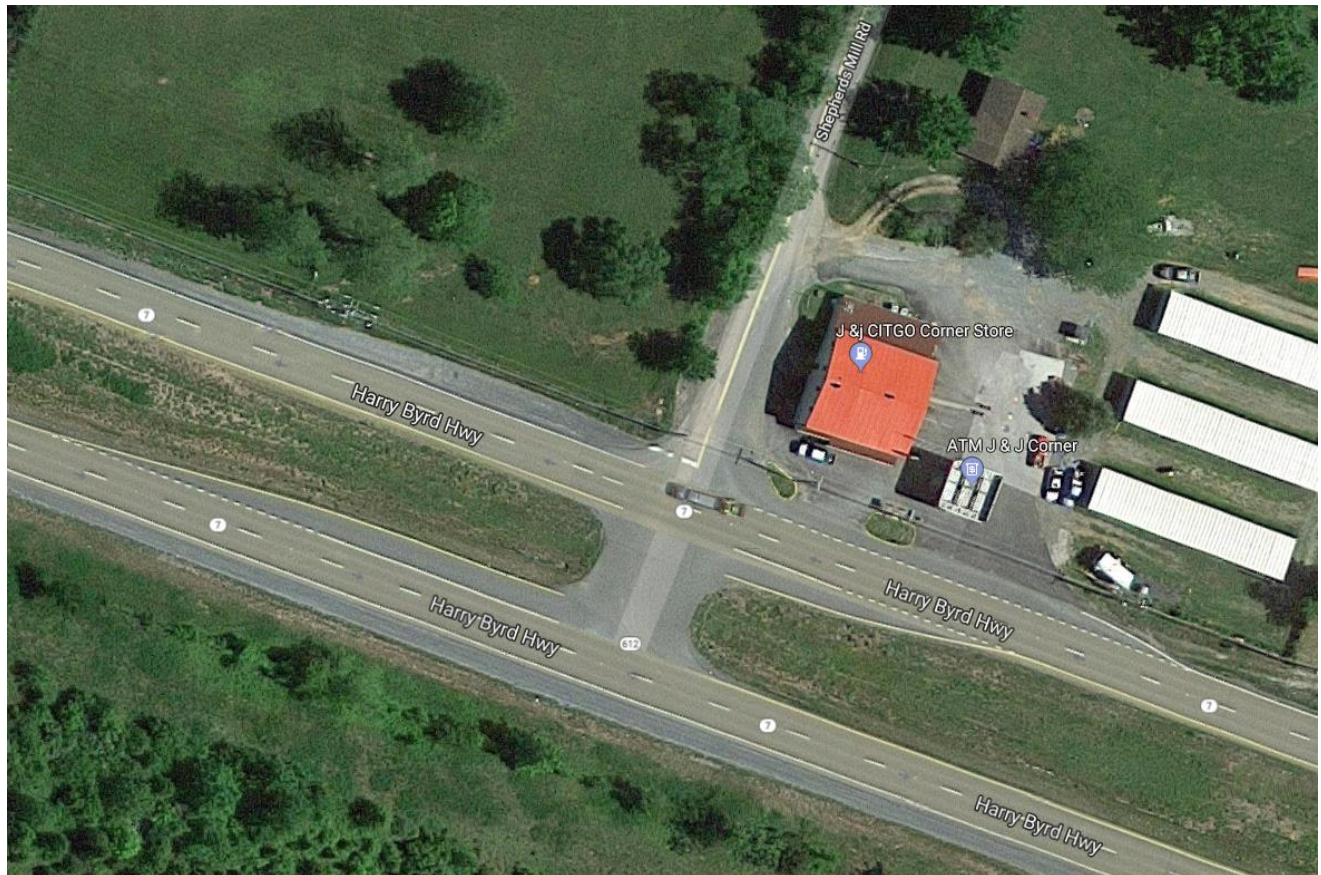
Route 7 and Route 612 is a three-leg intersection with the Route 612 approach operating under STOP sign control. See the following figure for an aerial view of existing conditions

The review found 12 crashes resulting in 5 injuries and 0 fatalities. The most frequent crash type (8 of 12) was angle crashes, 7 of which were vehicles on Route 612 failing to yield the right of way to westbound vehicles on Route 7.

1. Improve sight distance to the east by removing vegetation, cutting back the slope on the north side of Route 7.
2. Install signing to encourage traffic to use Route 7 and Route 340 instead of Route 612 to go to and from West Virginia.
3. Install optical speed bars on Route 7 westbound to possibly reduce the speed of traffic approaching the intersection.
4. Install centerline in the crossover.
5. Refresh the stop bar on Route 612.
6. Widen and extend the westbound right turn lane to Route 612 North.
7. Modify crossover to allow eastbound traffic to turn north onto Route 612 but not allow southbound Route 612 traffic to cross the westbound lanes to turn left onto eastbound Route 7. Close westbound left turn lane to Route 7 eastbound. Extend westbound left turn lane at Hawthorne Ln.
8. Raising the grade of the sag vertical curve in the westbound lanes east of the intersection.

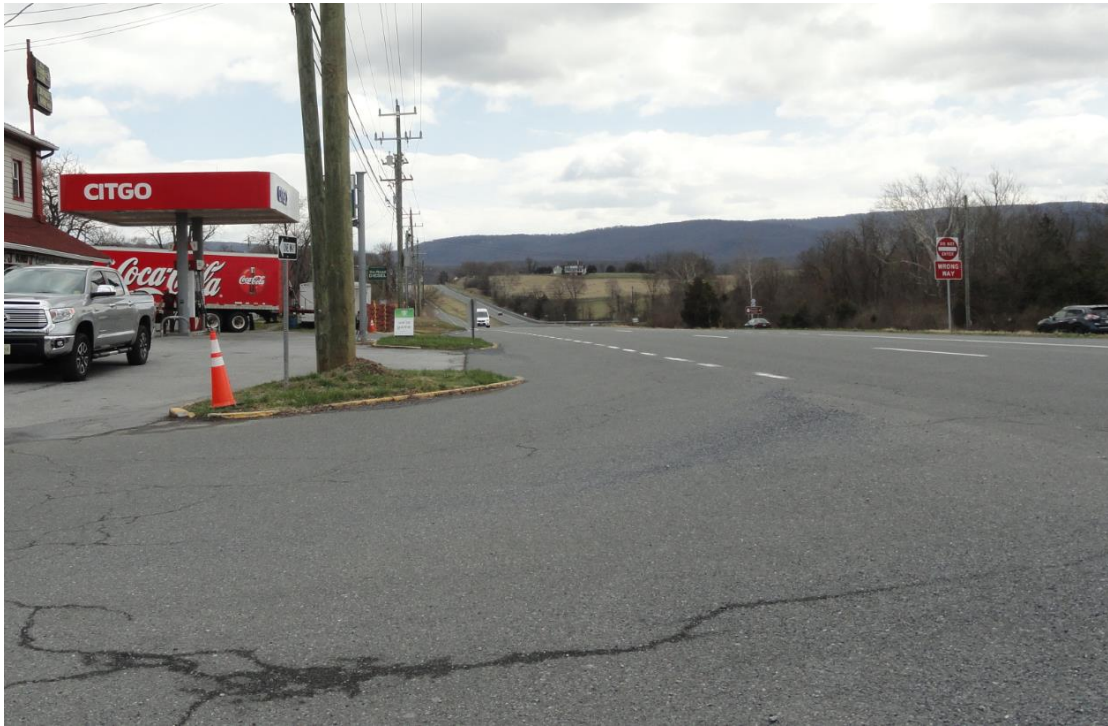
Sight Distance to the east while stopped on Route 612 is being limited by a business entrance, vegetation, an embankment, and a sag vertical curve.

Sight Distance, Rt 612 Looking to the east in the westbound lane

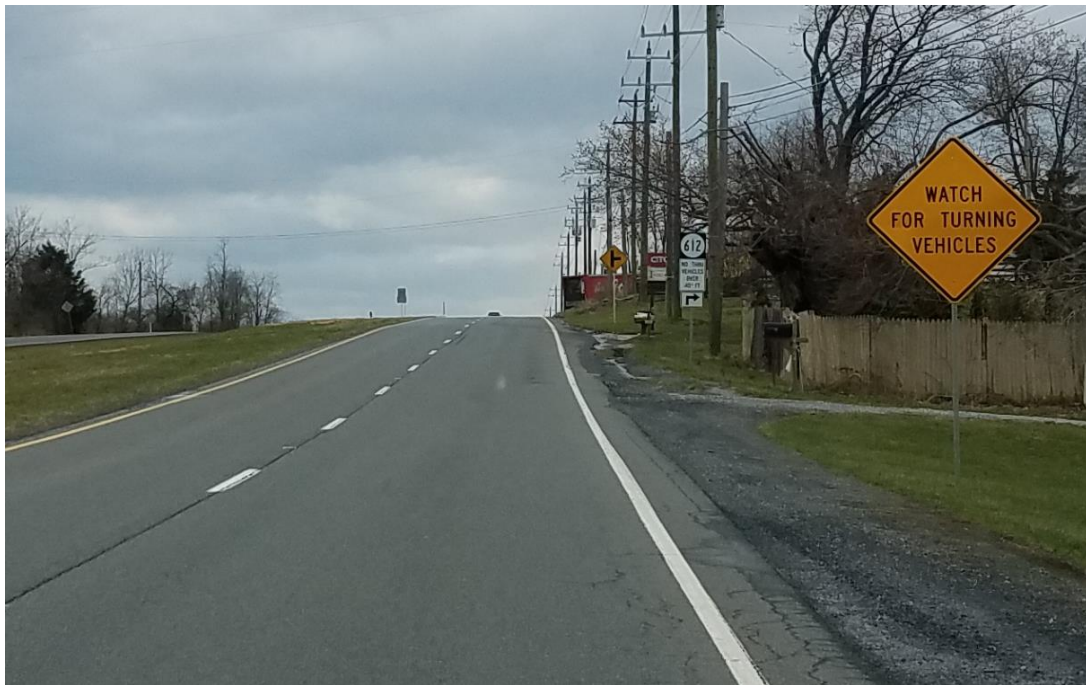
The Route 7 westbound “right turn lane” is too narrow to allow right turning vehicles the ability to completely move out of the westbound thru lane.

There is an existing WATCH FOR TURNING VEHICLES and an Intersection warning sign on the right shoulder of westbound approach to the intersection.

Route 7 westbound approaching Rt 612

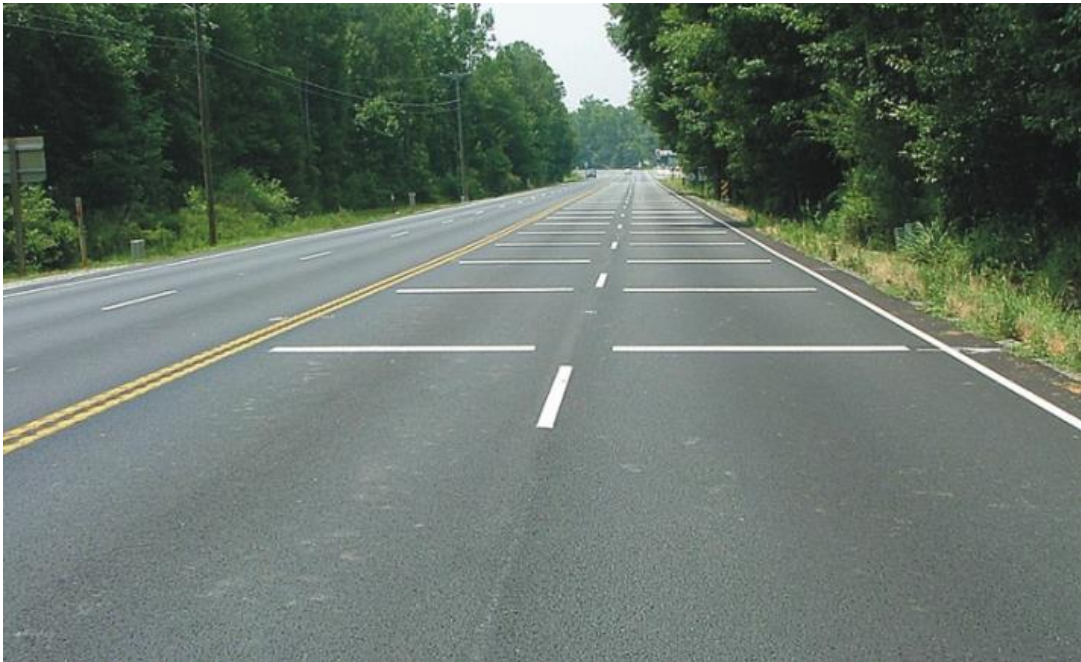
Example of Optical Speed Bar Markings for westbound Route 7

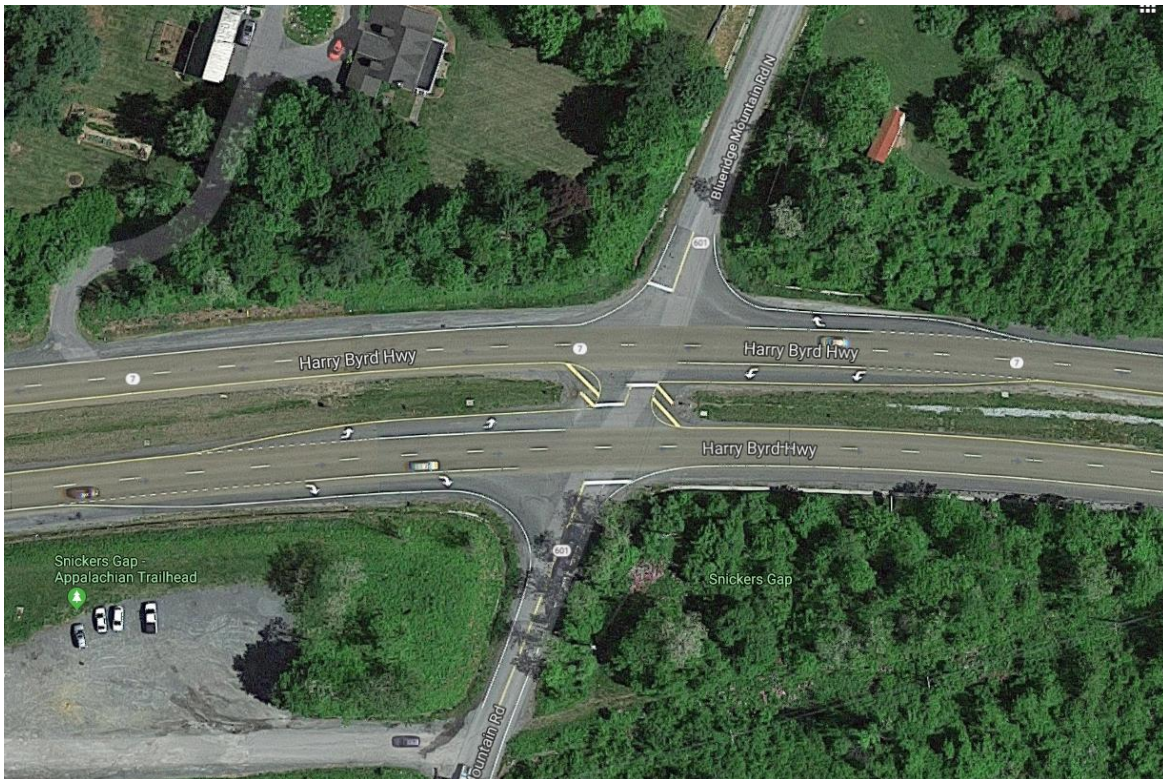
Route 7 and Route 601 is a four-leg intersection with the Route 601 approaches operating under STOP sign control. See the following figure for an aerial view of existing conditions

The review found 9 crashes resulting in 4 injuries. The most frequent crash type (8 of 9) was angle crashes of which 4 occurred in the eastbound lanes and 2 occurred in the crossover.

1. Convert existing intersection warning signs with flashers to a dynamic flasher that is turned on when there are vehicles on Route 601 and/or in the crossover.

2. The stop bars in the crossover should be removed.
3. Install signs on Rt 601 approaches indicating the requirement to yield to traffic in the crossover.
4. Create a connection from the parking area to the Appalachian Trail that would not require hikers use the shoulder of Route 7.
5. Widen crossover to allow for a two-stage crossing.
6. Lower the crest vertical curve on eastbound Route 7 to increase the sight distance.

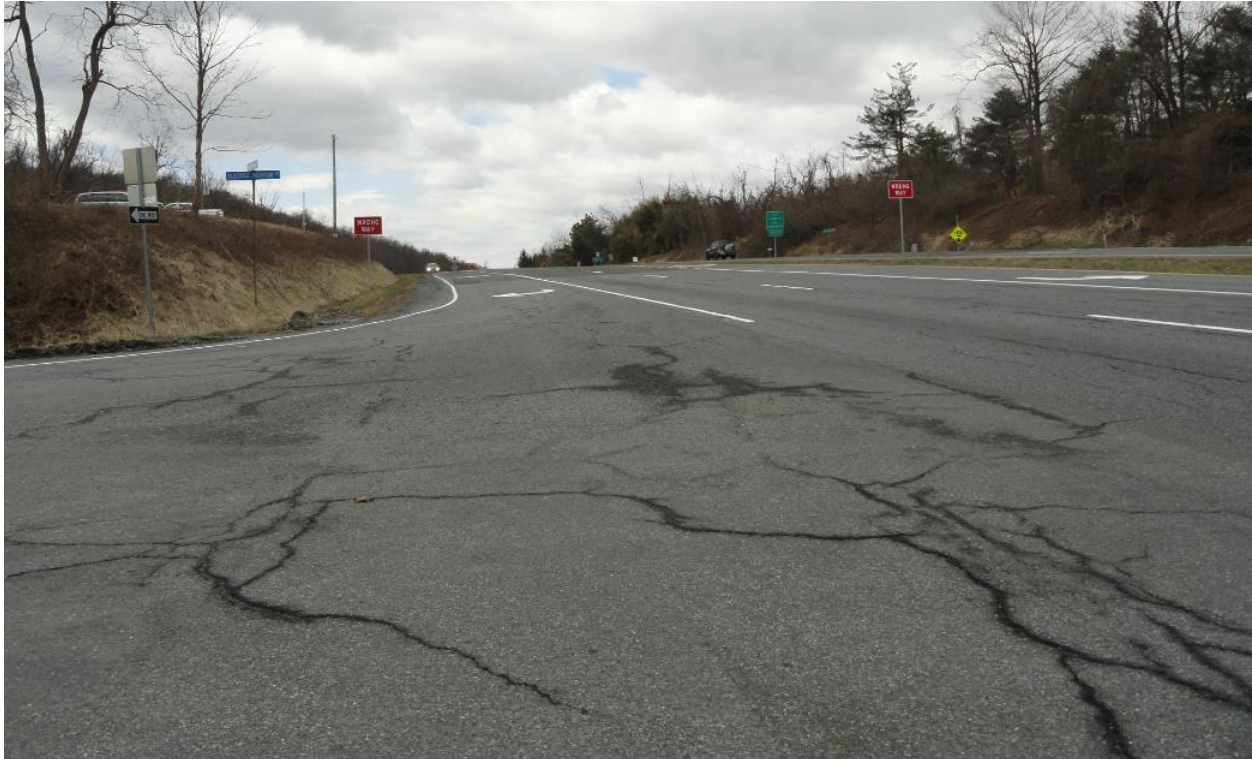
Sight Distance looking east from Rt 601

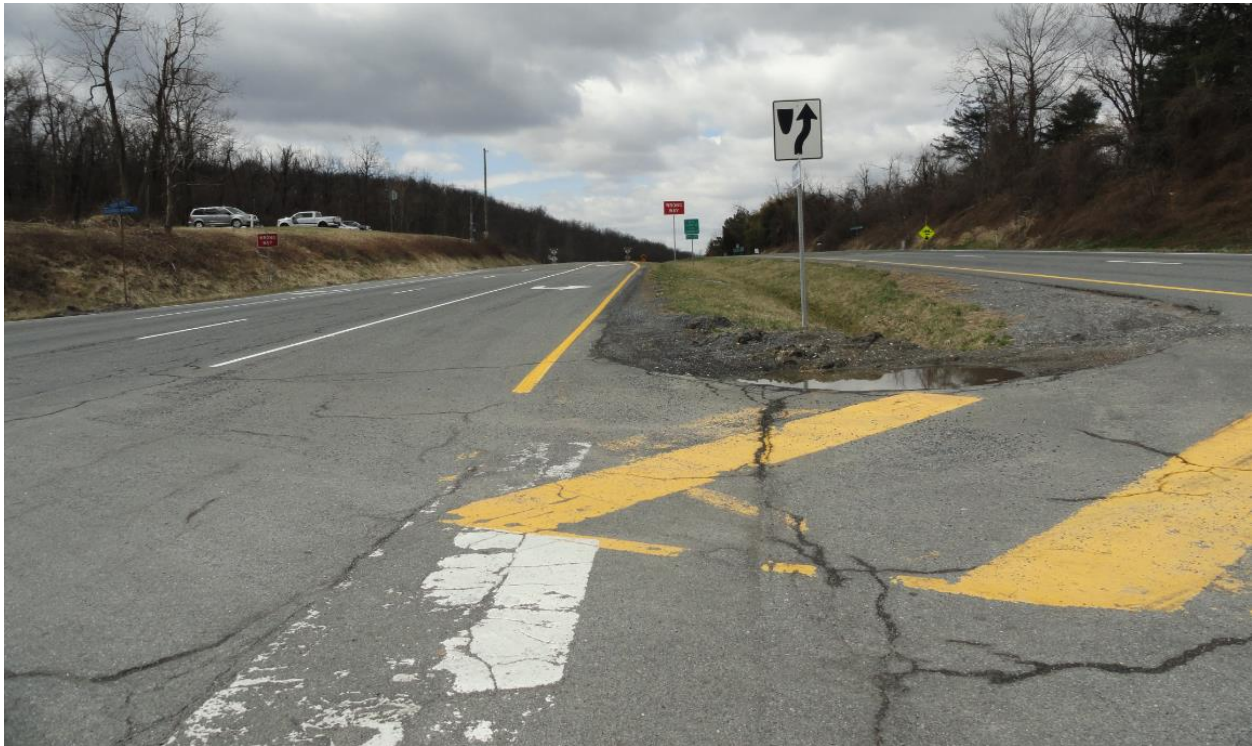
The narrow crossover makes it difficult to complete a two-stage crossing. It appears drivers may be looking for a gap in both directions, become impatient, and take undue risks.

Sight Distance looking east from crossover

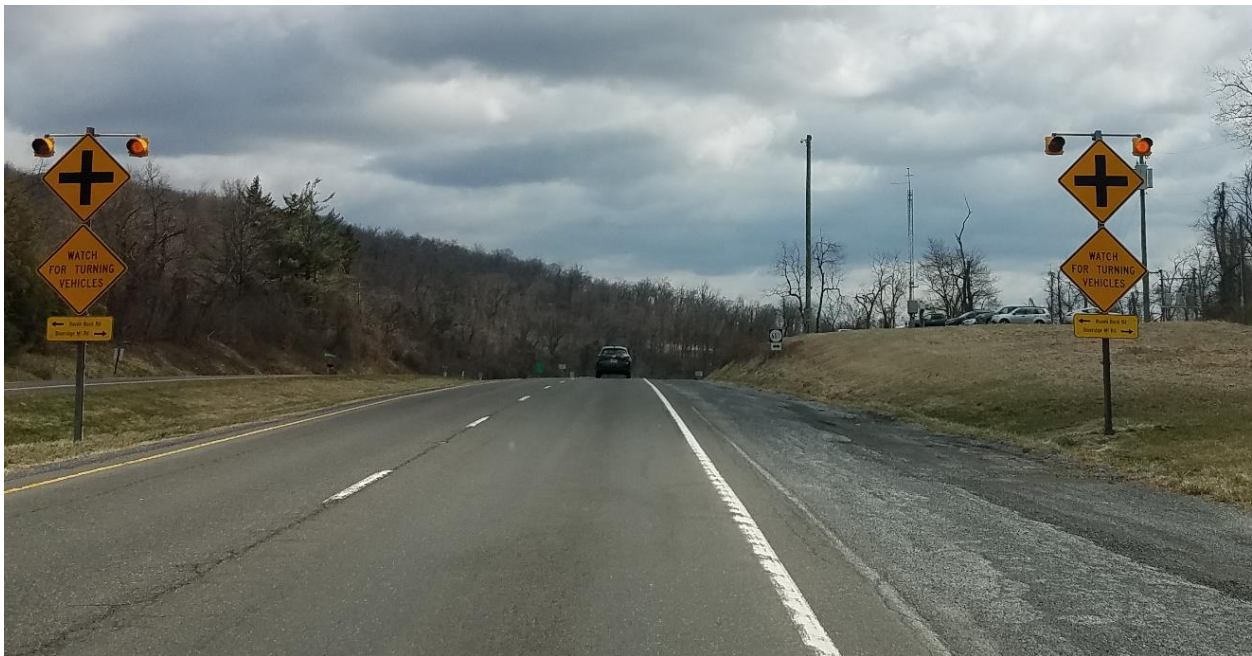
The sight distance to the west in the eastbound lane is limited by a crest vertical curve both for northbound vehicles attempting to cross the eastbound lanes and for westbound left turners attempting to cross the eastbound lanes.

Route 7 eastbound crest vertical curve hiding intersection

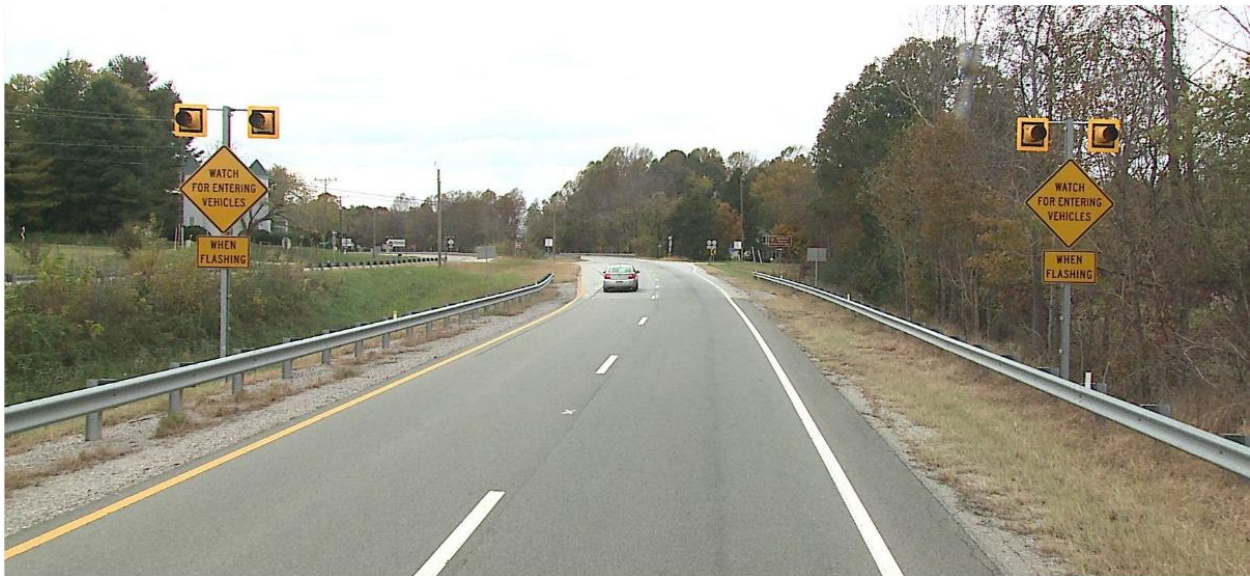
Example of Dynamic Warning Flashers

There is an existing programmed safety project to provide a dynamic warning flasher on the Route 7 eastbound approach to warning eastbound drivers that vehicles are entering. Funding for the preliminary engineering will be available in September 2023 with construction funding available in March 2024.

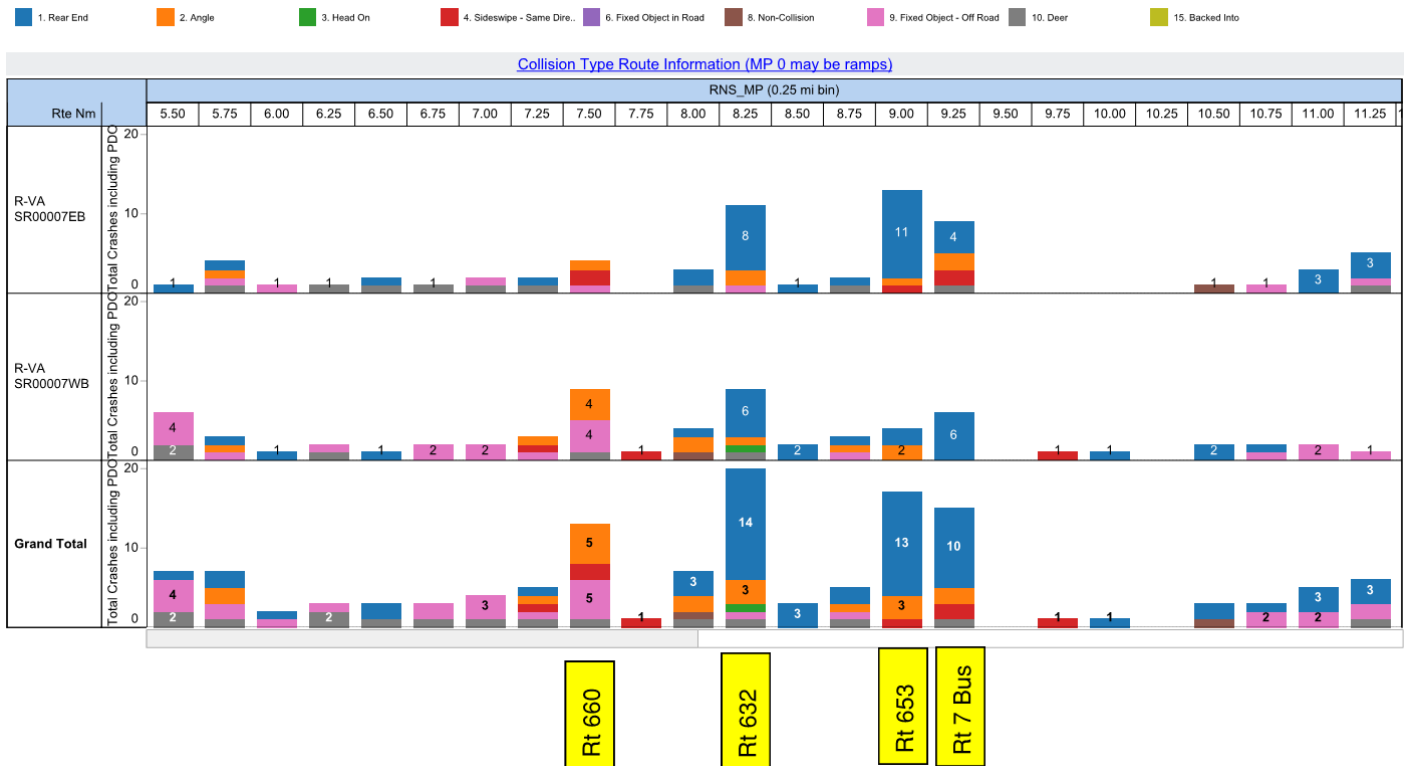
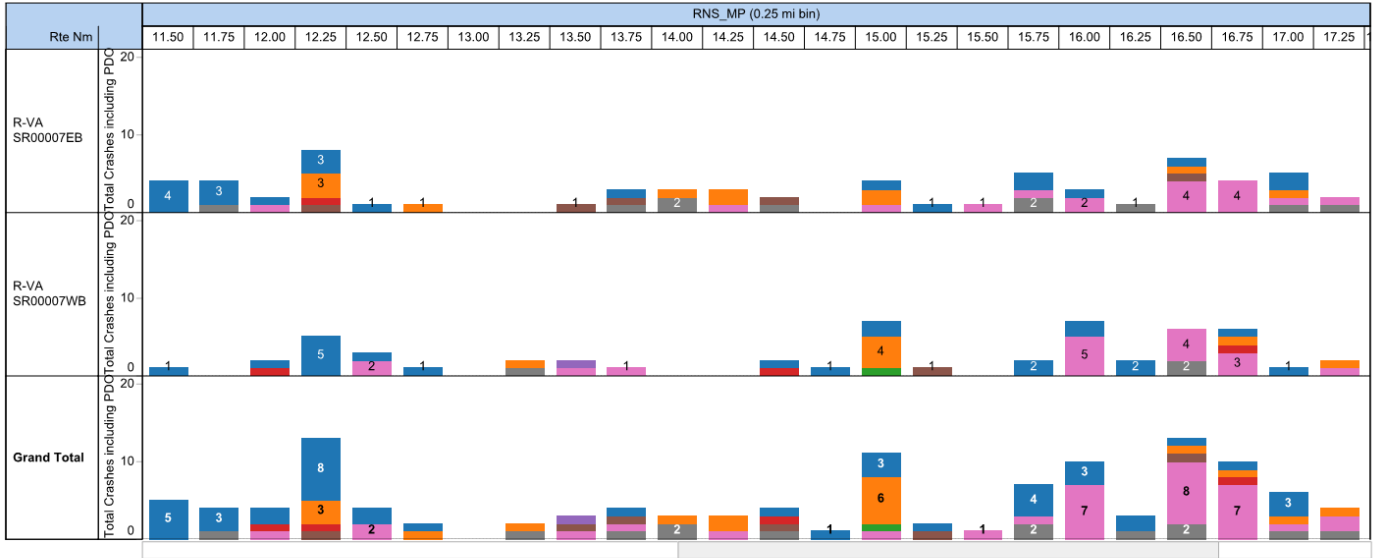
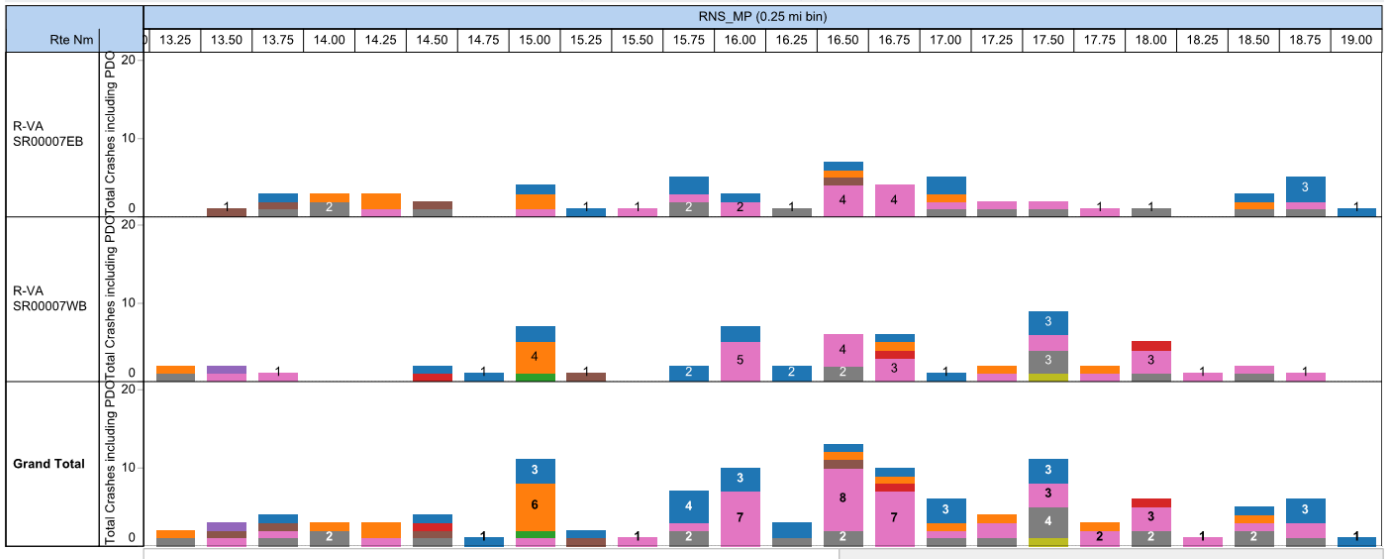
The next three charts show the frequency and type of crashes for each 0.25 mile section

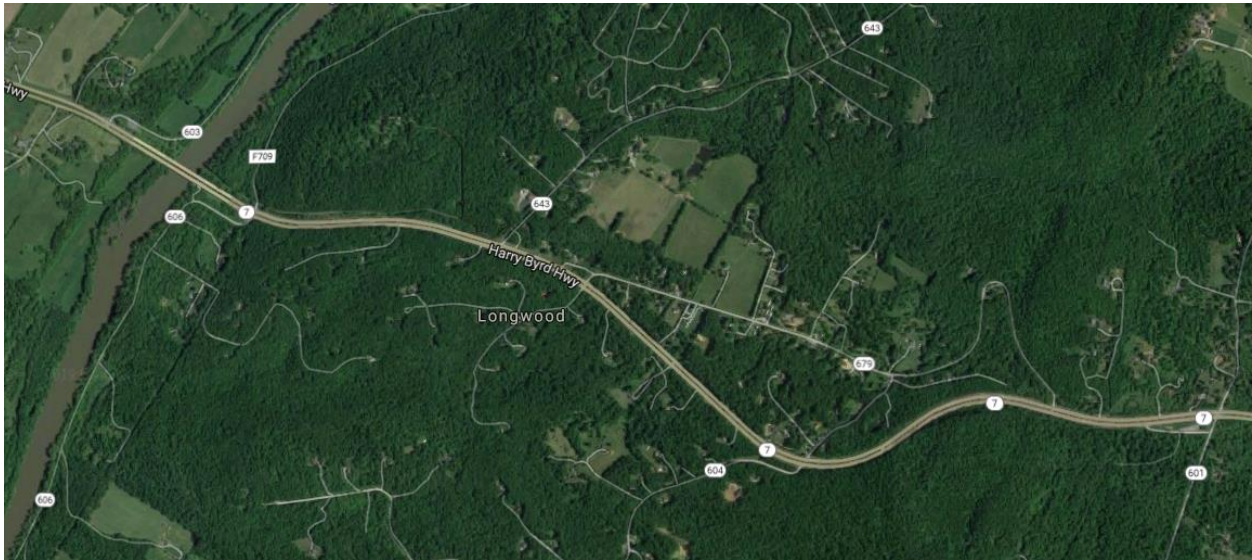
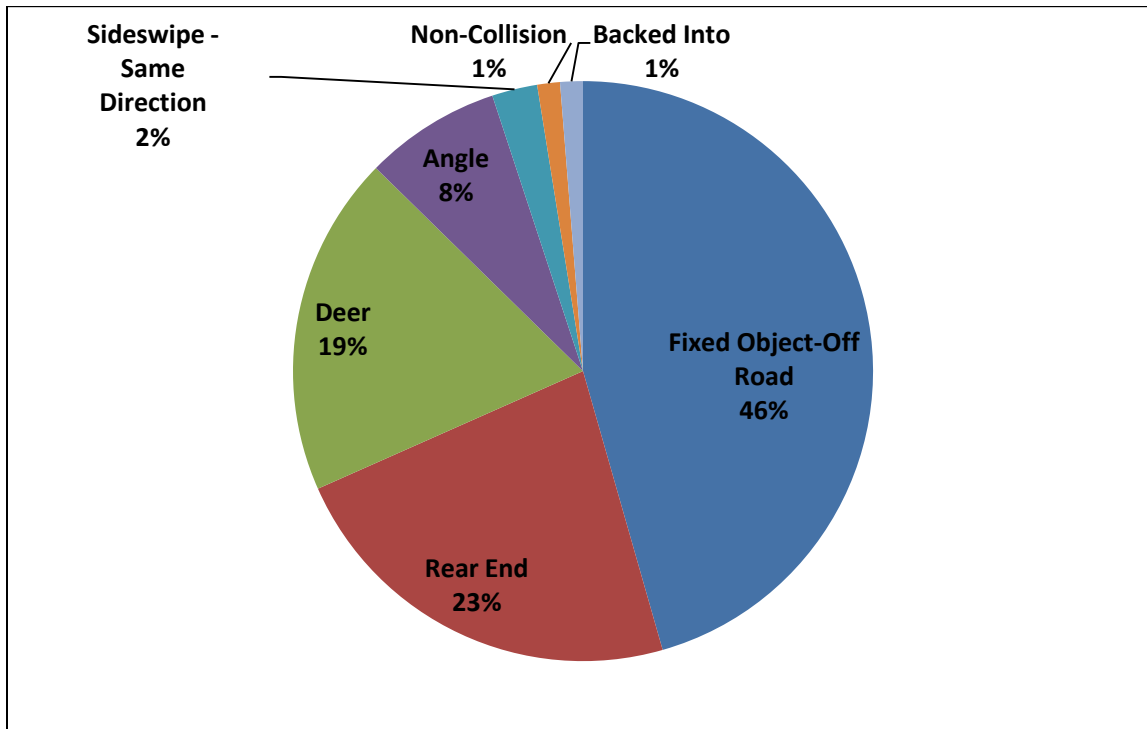
Route 7 Crashes 2016-2018, MP 15.75 – 18.75

Summary of crashes: MP 15.75- MP 18.75 0.28 mi. W North Hill Ln – 0.05 mi. E Route 679 (W Intersection)

- 79 crashes, 46 injuries, 0 fatalities
- 36 Fixed Object Off-Road, 18 Rear End, 15 Deer, 6 Angle, 2 Sideswipes Same Direction, 1 Non-Collision, 1 Backed Into
- 39 Speed related
- 52 daylight, 27 low light
- 35 Eastbound, 44 Westbound

- 36 Fixed Object Off-Road: In 19 of the 36 crashes the driver was exceeding the speed limit or the maximum safe speed. Other factors noted; 5 DUI, 4 Snow/Ice related, 2 Driver Fatigue, 2 Tire Failure, 1 Medical Emergency, 1 Eluding Police, and 1 Avoiding Deer.
- 18 Rear End: In 14 of the 18 crashes the driver was exceeding the speed limit or the maximum safe speed. Other factors noted; 5 were congestion related, 2 cited sun glare going eastbound, 2 were slowing for deer, 1 was in a work zone, 1 involved a farm tractor, 1 was a secondary crash, 1 DUI, 1 driver distraction.
- 6 Angle: 2 were Snow/Ice related.
- 15 Deer: 11 of 15 occurred in the months of October and November

1. The paved shoulders should be widened 2 – 4 feet in areas where the existing shoulder can accommodate. Edgeline or shoulder rumble strips should be installed as shoulder widening occurs and with maintenance repaving projects.
2. Based on the high operating speeds, install curve warning and chevrons signs on the westbound lanes on the curve at the Route 604 intersection.
3. Law Enforcement should conduct targeted speed enforcement on a more frequent basis.
